## Project Profiles

### Ritz Carlton Hotel – Philadelphia, PA

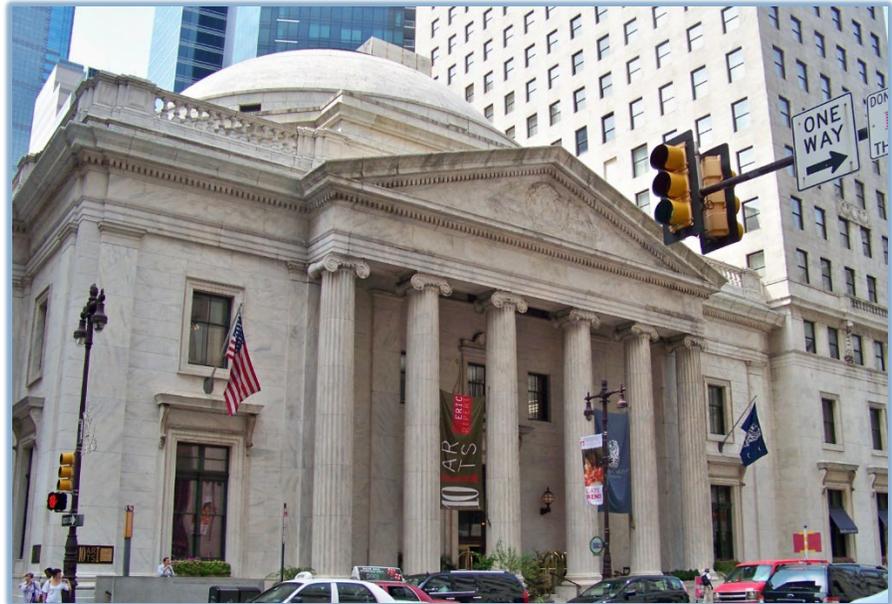
The Ritz-Carlton Philadelphia is a 330-room hotel located in a 30-story skyscraper in Center City, Philadelphia. The Ritz-Carlton is located in the structure that was originally known as the Girard Trust Building when it was built in 1931. The building is listed in the National Register of Historic Places and is therefore subject to the requirements of maintaining its original appearance and utilizing equivalent materials for restoration. The building's façade was constructed with a marble stone veneer. The marble is anchored to the terracotta back-up and steel structure. A setback located at the 28th floor serves as a promenade and decorative balconettes are located at Floors 4, 12, and 19. The setback is detailed with a marble cornice and parapet wall and the balconettes are detailed with marble railings and spindles.

The primary repairs were related to the marble façade which had deteriorated due to weathering. The marble surface had deteriorated in many locations due to freeze-thaw damage. The repair called for cleaning the deteriorated surface to sound material and then sealing it with a glazing compound. Deteriorated also occurred around original architectural details in the marble which called for specialized marble craftsmanship to repair. Displaced marble panels were also discovered which represented an immediate safety concern. Sidewalk sheds were installed in order to protect pedestrians on the sidewalk below. The repair for displaced marble panels called for removing the displaced panel, installing masonry anchors, and reinstalling the panel. The marble railing around the balconette was also discovered to be deteriorated. The loose or deteriorated marble was removed with chipping hammers and patched with colored mortar to match the existing surface. All of the marble repairs required mock-ups which were approved by the Philadelphia Historic Commission before repairs could proceed.

The parapet walls at the 28<sup>th</sup> floor were also found to be in poor condition. The cast-stone veneer was deteriorated by freeze-thaw damage and the ornamental carvings were cracked and in danger of collapse. Sidewalk sheds were again installed to protect pedestrians from falling stone. The repairs required taking detailed measurements and photographs of the stone details and carvings in order to create shop drawings. Shop drawings were created and approved by the Philadelphia Historic Commission and replacement pieces were created in the same material.
